DEPARTMENT OF NATURAL RESOURCES
DIVISION OF OIL, GAS AND MINING

RE: Site Inspection, Native Asphalt Company, Cameron #1 Project,
S/047/036, Uintah County, Utah

Date of Inspection: October 3, 1991

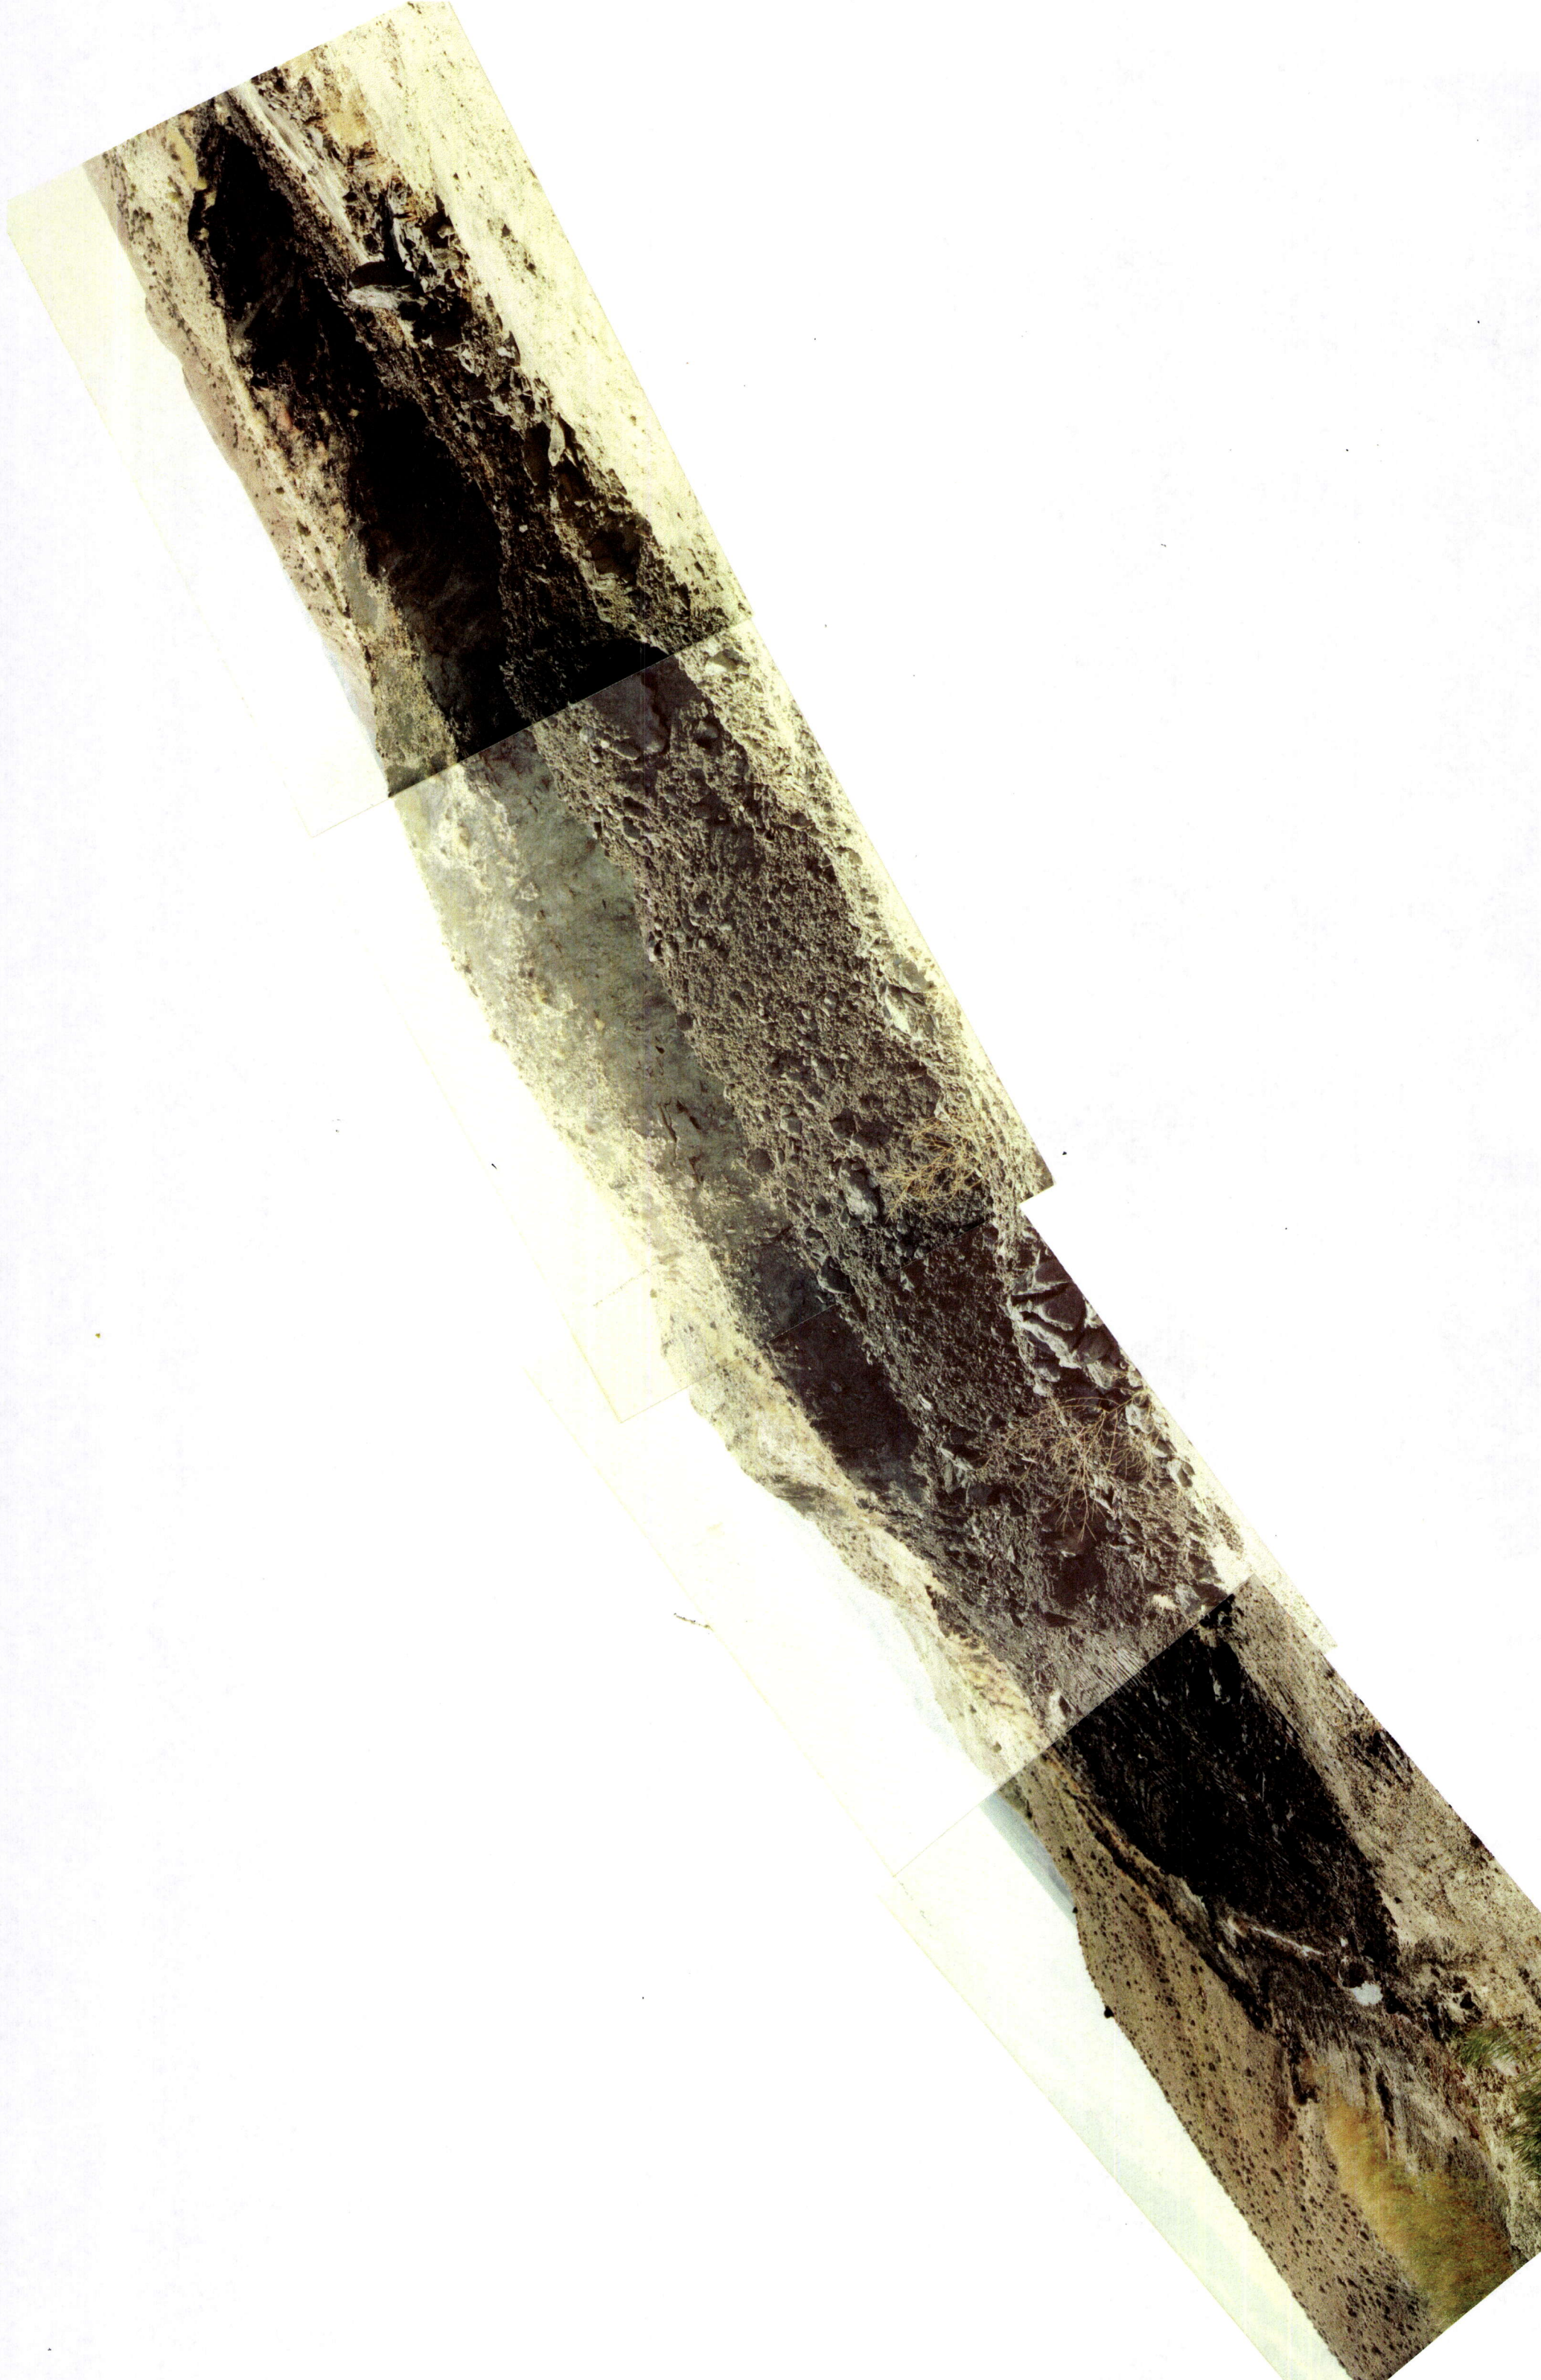
5/6477/0266
NATIVE AGRIKULT CO
CAMERON #1
10/3/91
PROGRAMA FROM W--E
SCARPED AREA WHICH
STOWING TILES
WAS SEEDS. WHICH NEED
-NOTE REMAINING TILES
ROAD (FIRE FIGHT) WHICH
TO BE REPAIRED

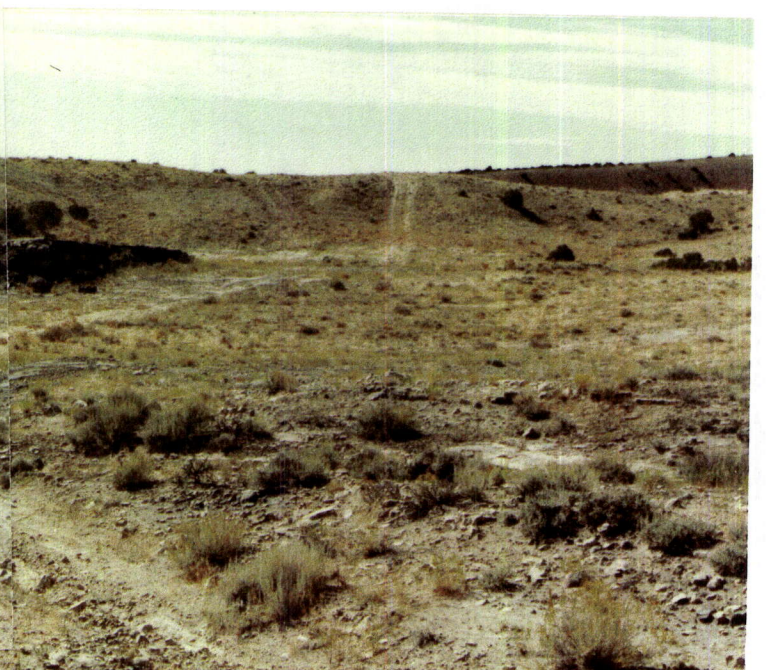
S/047/036 CAMERON #1
NATIVE ASPHALT Co.
10/3/91
WETLANDS AREA
NOTE BREACHED DIKE/ROAD AREA
